**BLACKSTONE RIVER BASIN
MILLBURY, MASSACHUSETTS**

**BRIERLY POND DAM
MA 00143**

PHASE I INSPECTION REPORT NATIONAL DAM INSPECTION PROGRAM

OCTOBER 1978

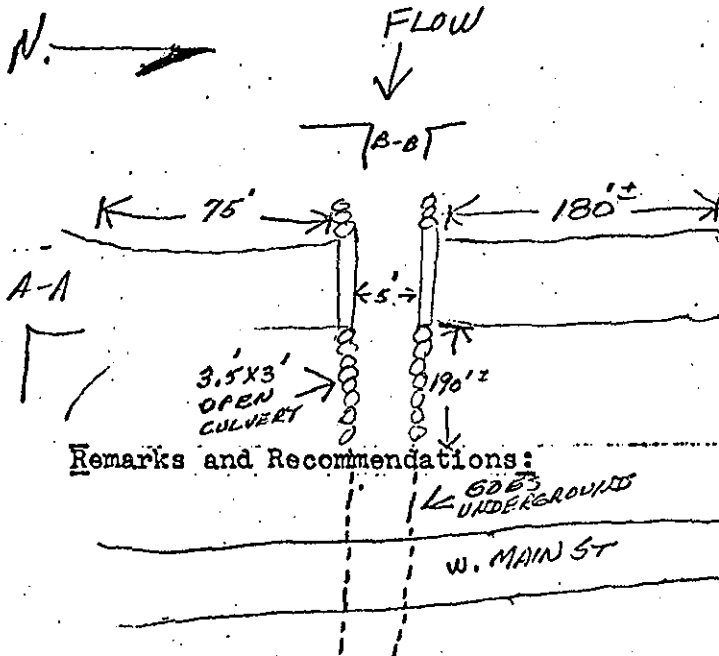
A-A END VIEW DAM

EARTHEN DAM W/ A 5' DISCHARGE GATE WHICH IS
IN GOOD CONDITION. NUMEROUS 3"-18" TREES ON
FACE OF DAM.
